Collapse of newly built forest terrace walls and evaluation of possible mitigation treatments

Martinho A.S. Martins¹; Liliana B. Simões²; Nelson Abrantes¹; Jan Jacob Keizer¹

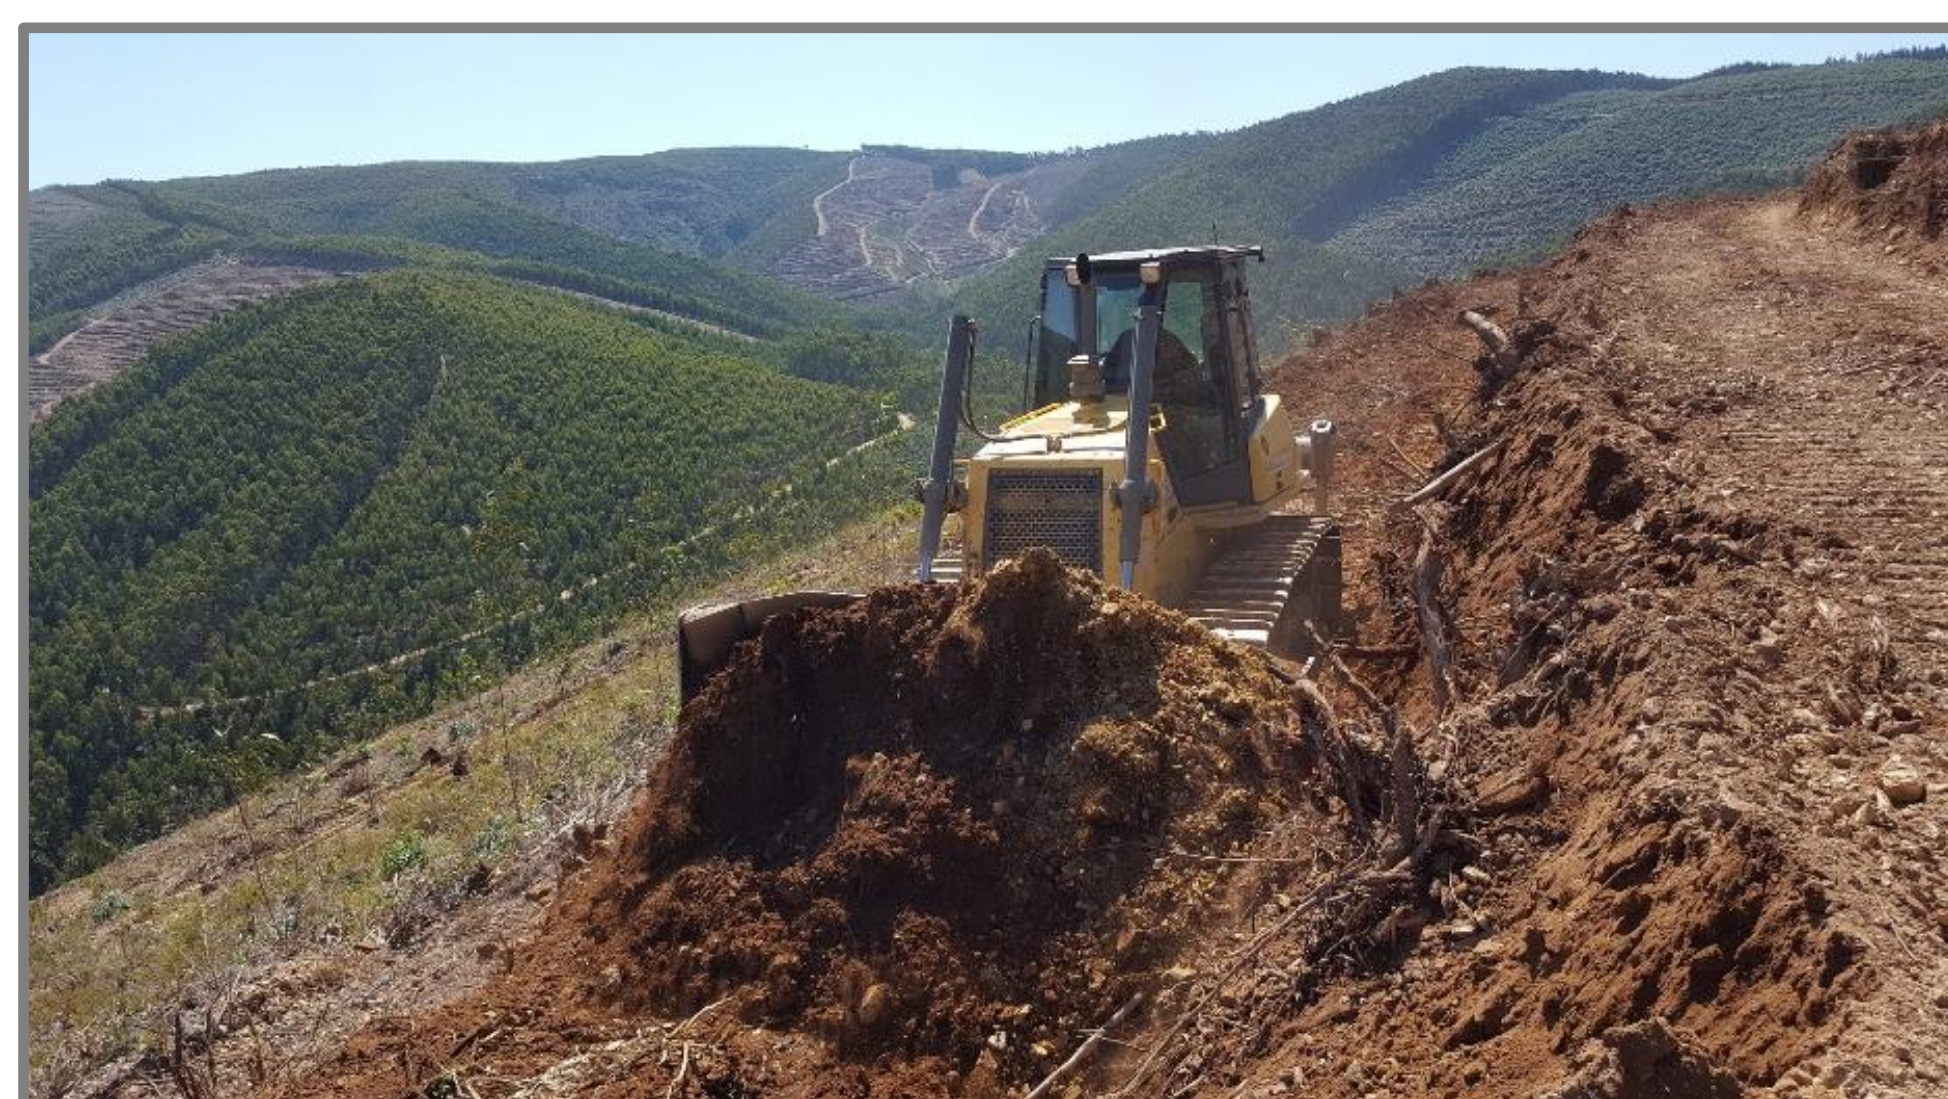
Figure 1 – Terraces being built by a bulldozer in July 2019 near the village of Boialvo (Anadia Municipality).

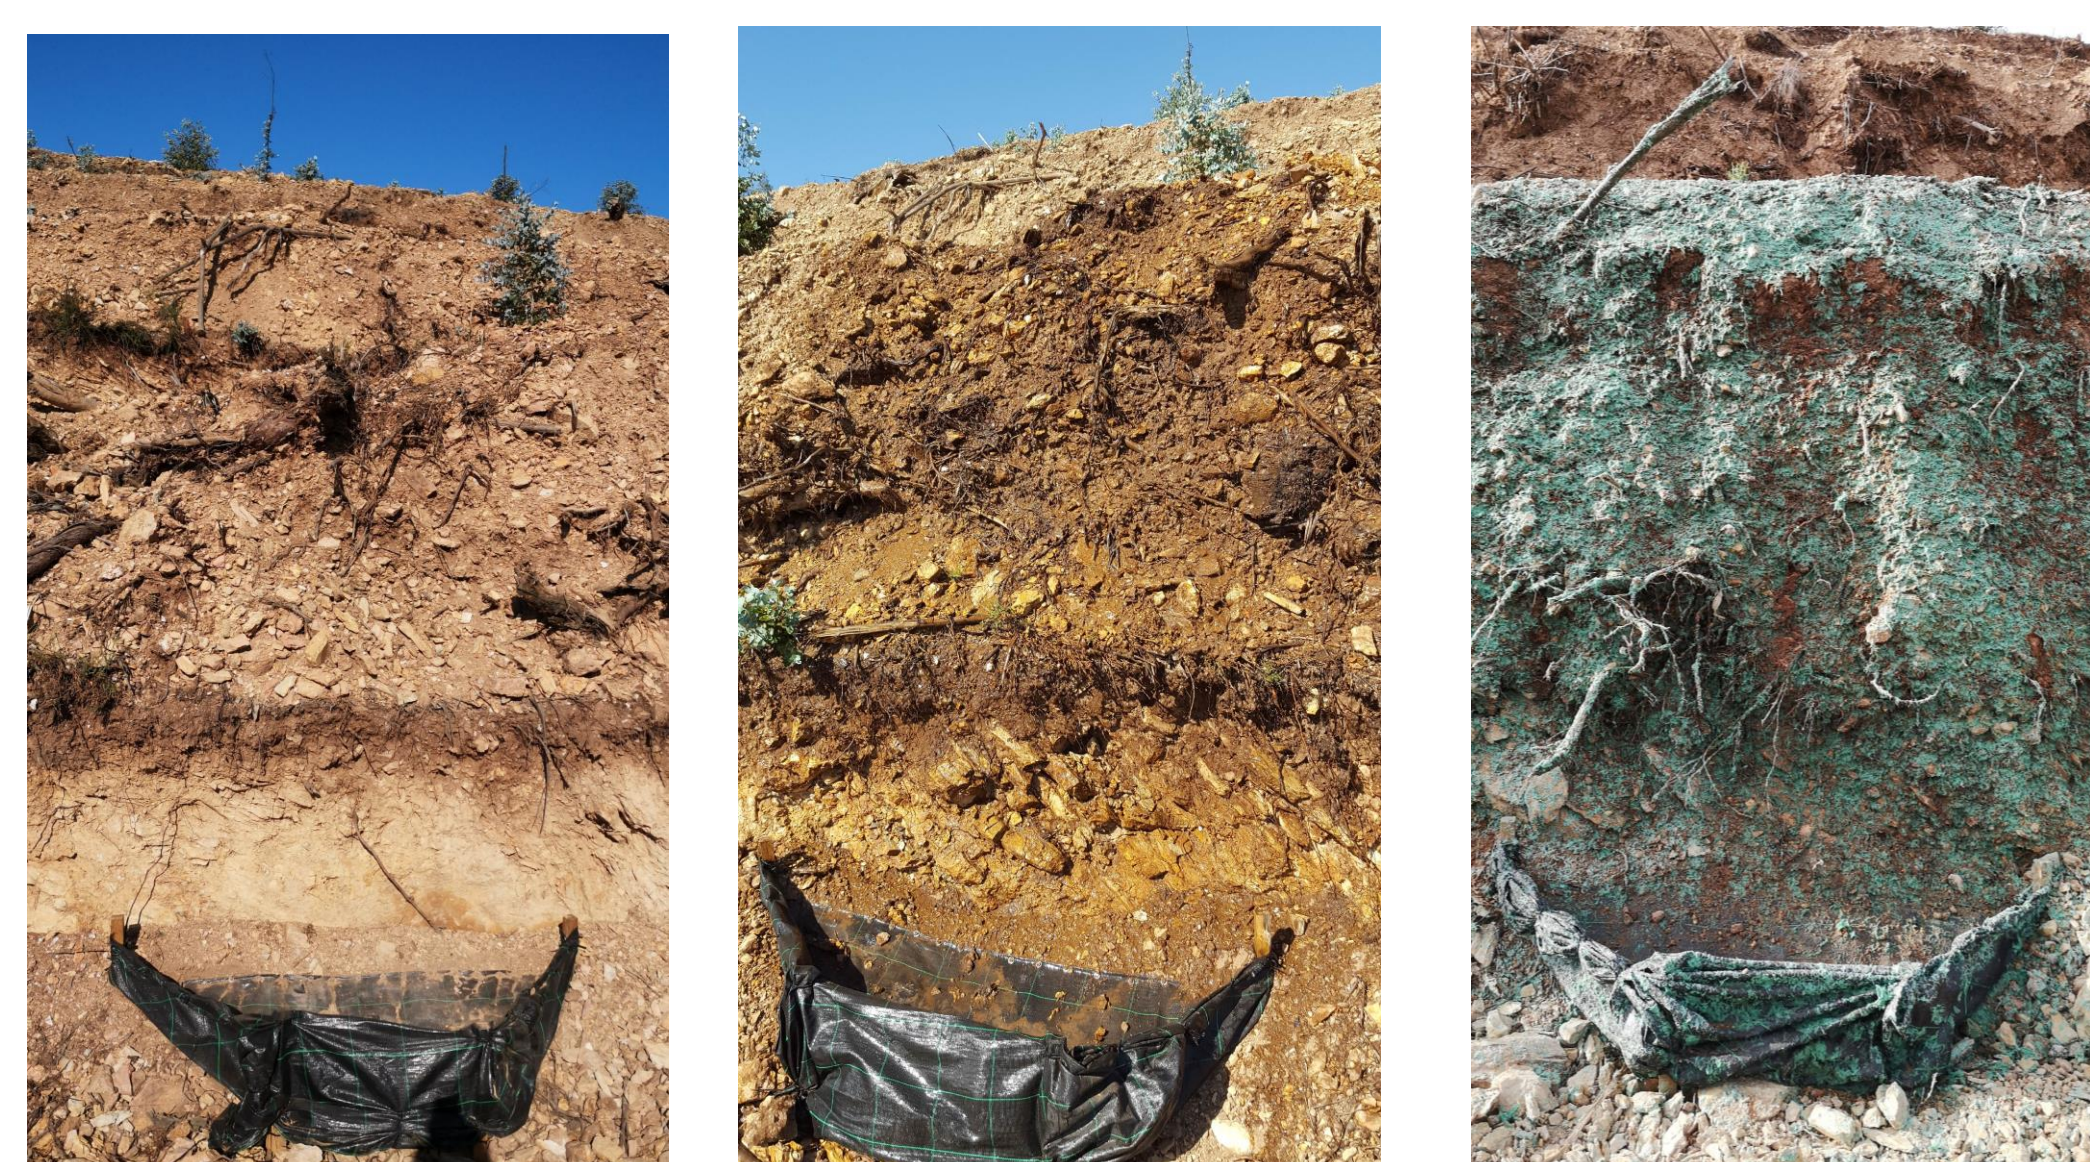
Figure 2 – Sediment traps installed in the bottom of the terrace wall (1) control (2) application of polyacrylamide (3) application of hydromulch.

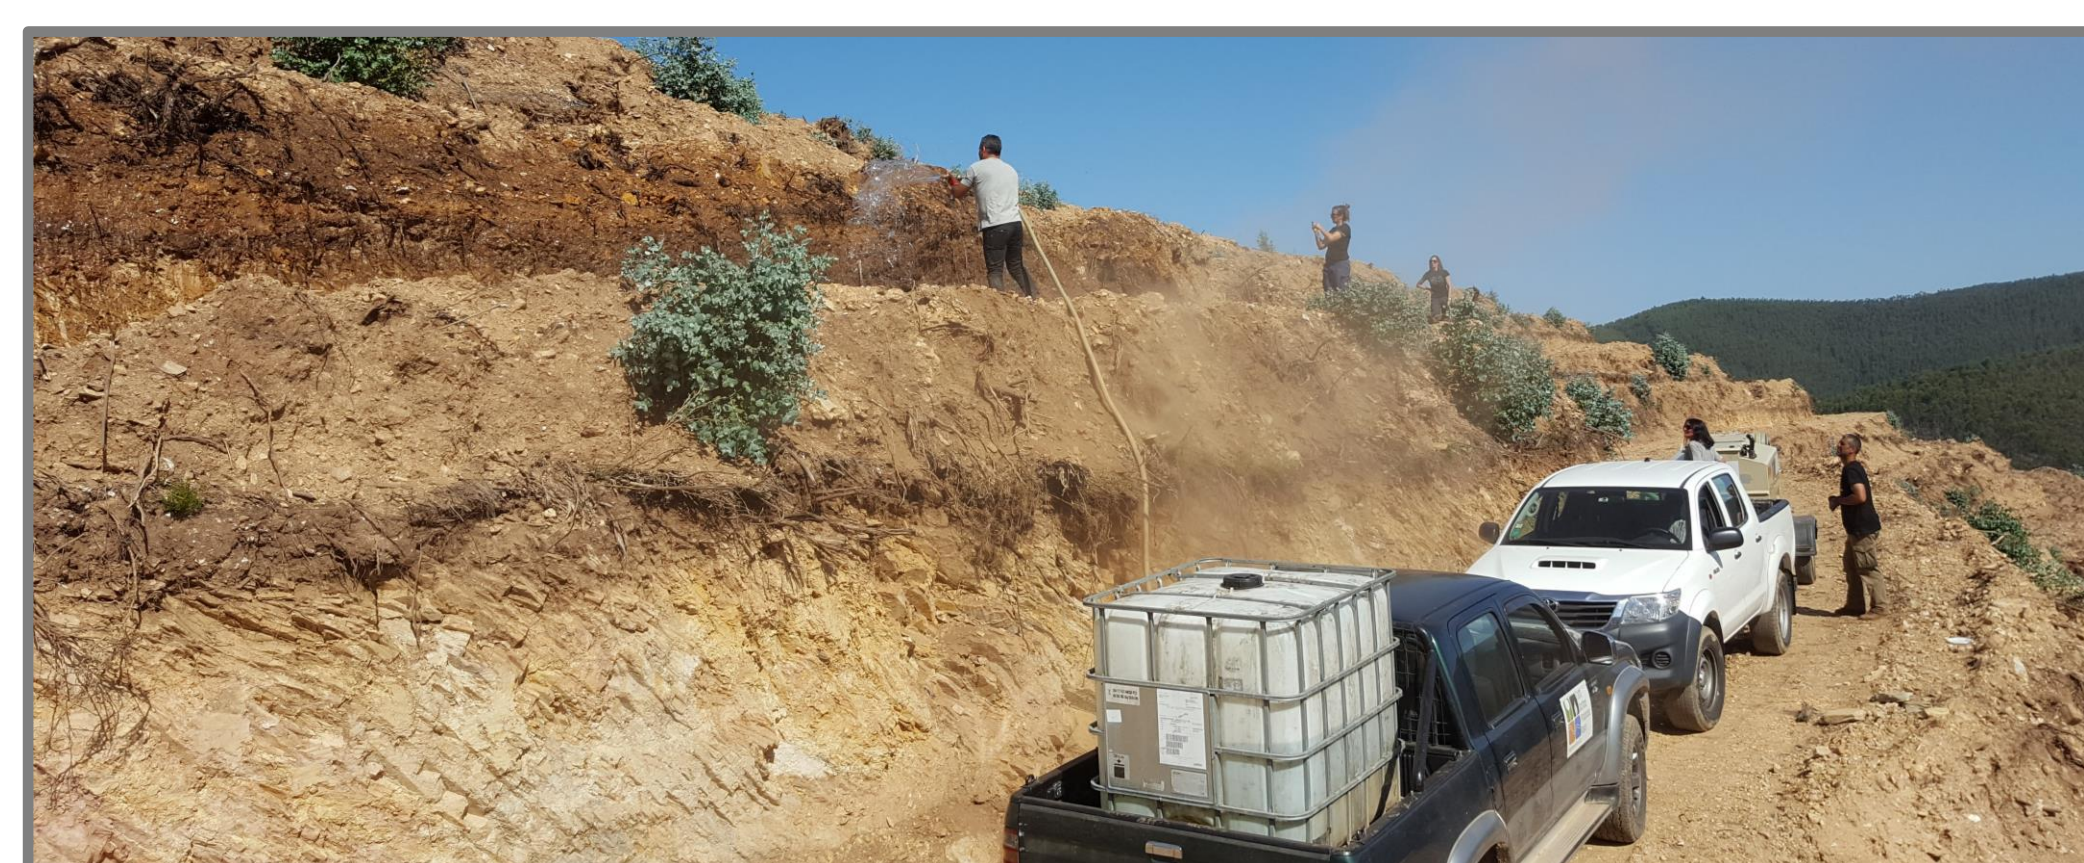
Figure 3 – Application of synthetic polyacrylamide by spraying the mixture using a hydroseeder.

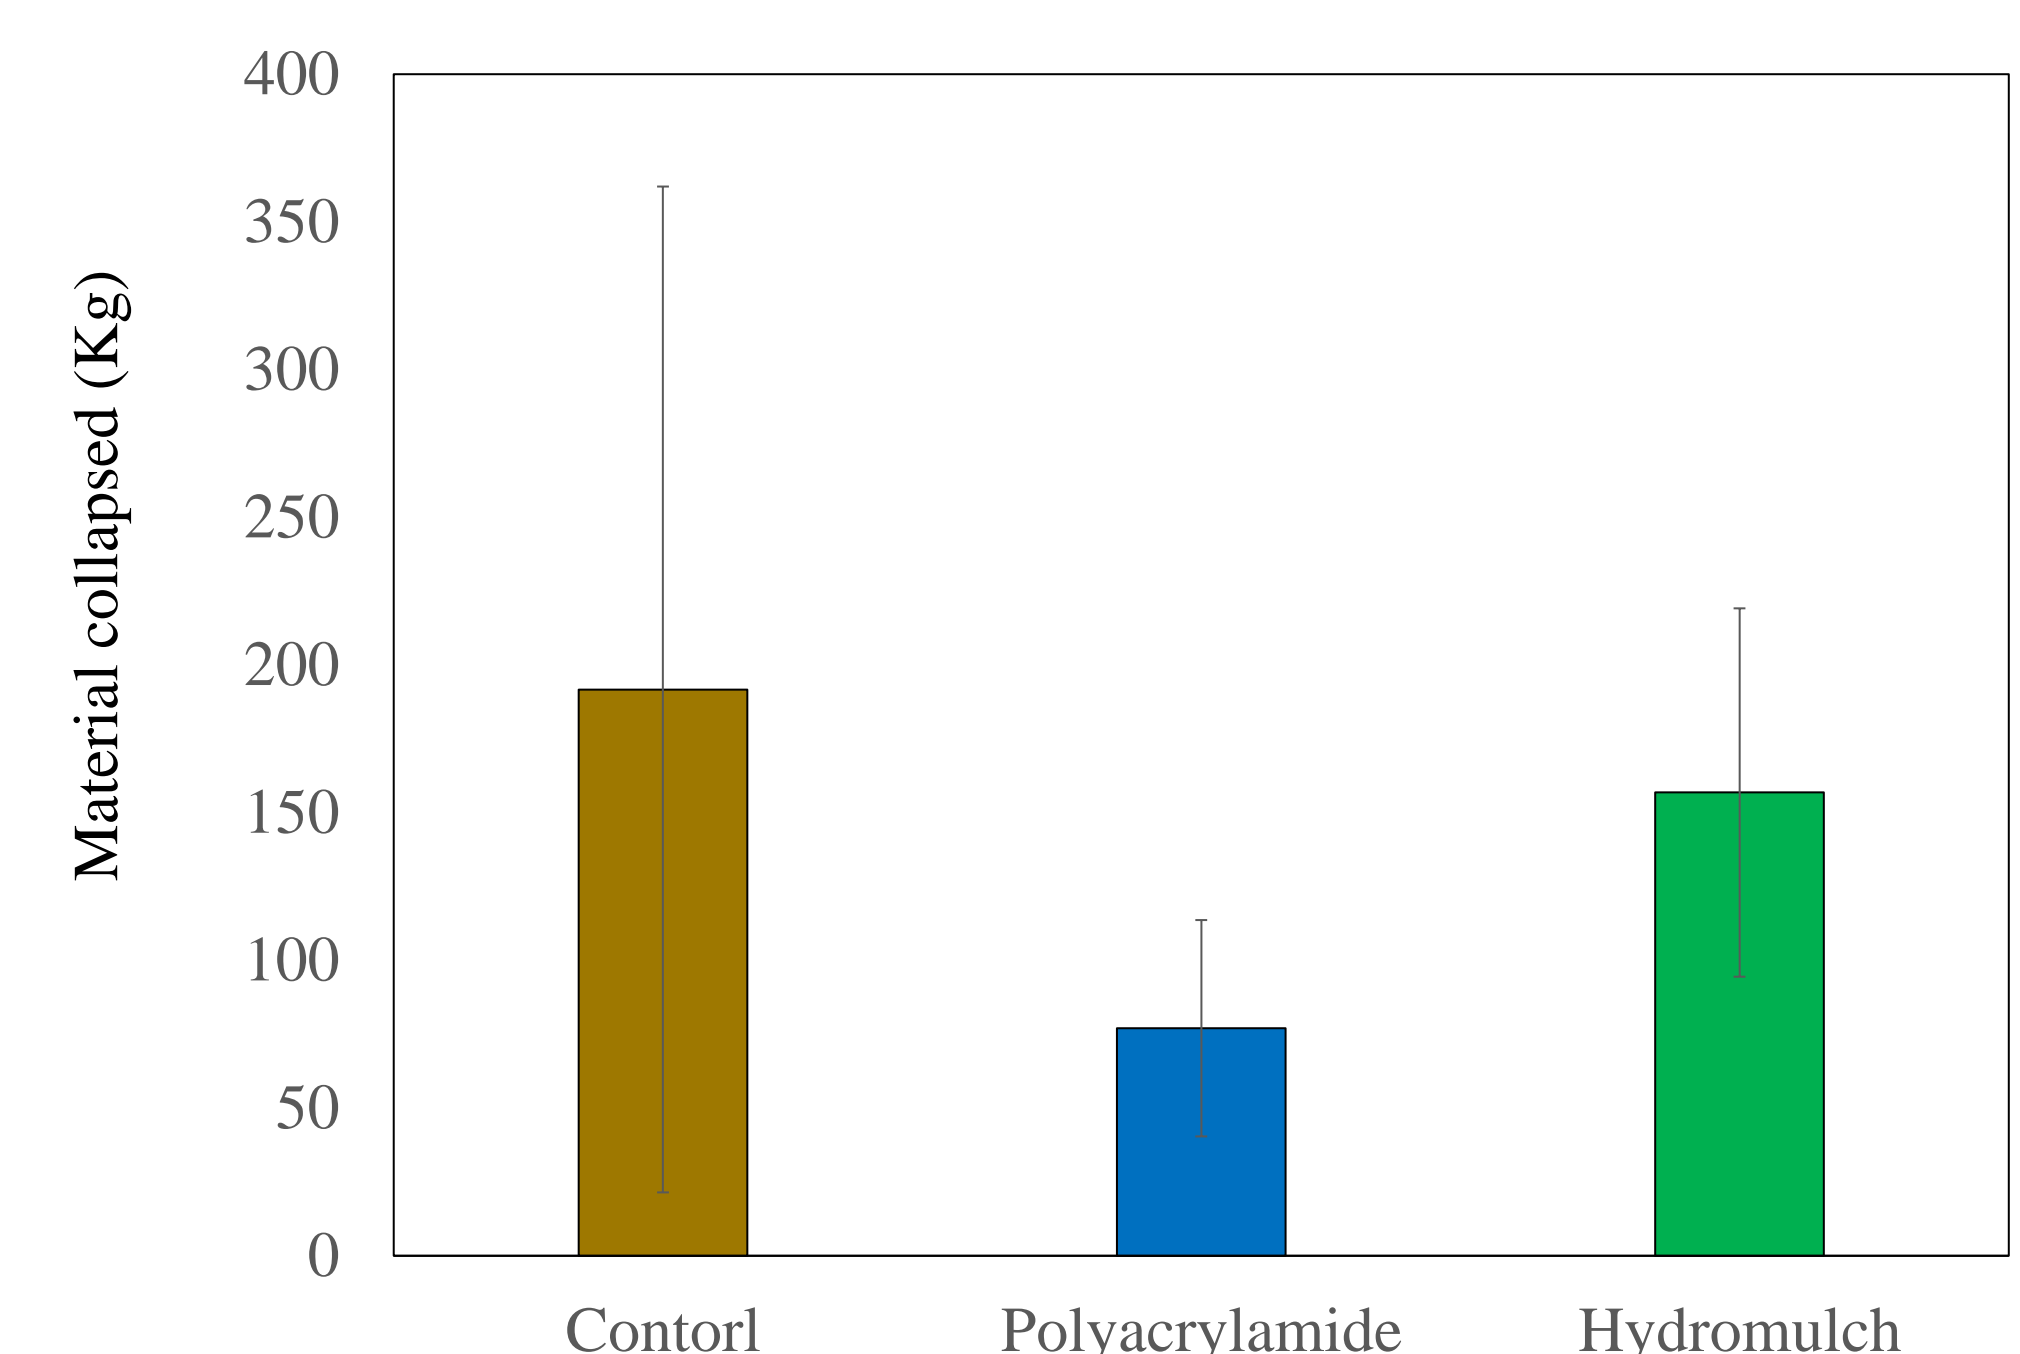
Preliminary results on bench terrace wall collapse show that the material fallen can amount on average 200 kg by each meter of the terrace line. In addition, hydromulch and polyacrylamide applications immediately after the construction of the terrace might reduce the fallen of material by 20% and 40% respectively. Yet during the first year, 4 of the 12 plots completely collapsed.

Figure 4 – Average of the total of material collapsed (kg) during the first 12 months after the construction of the bench terraces for the three individual treatments (control, polyacrylamide and hydromulch).
